Social and Spatial Flood Risk Analysis for Decision Making: Cases from Two Flood Prone Areas in Eastern Sudan

**Social and Spatial Flood Risk Analysis for Decision Making:
Cases from Two Flood Prone Areas in Eastern Sudan**
CMI Sudan Report, number 1, November 2024

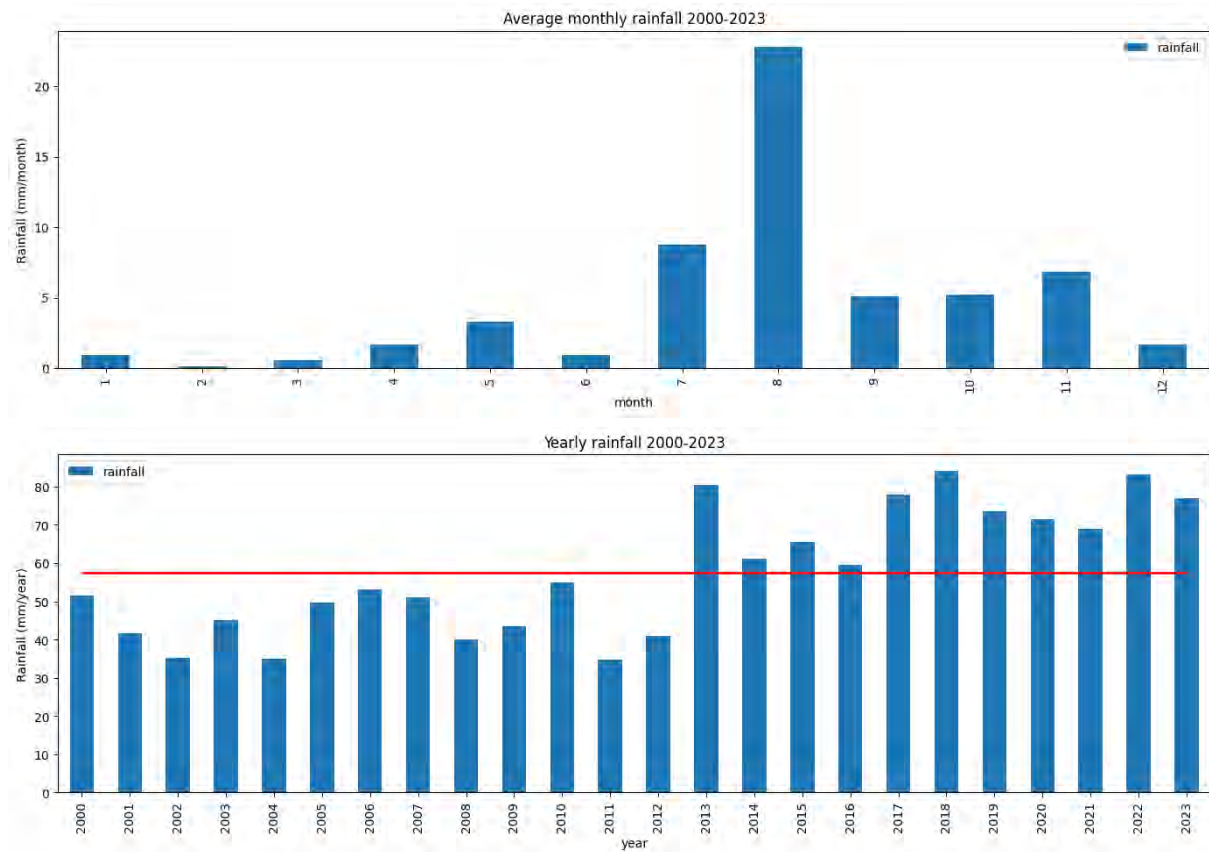
Figure 4: Monthly and yearly rainfall for the Arbaat catchment extracted from CHIRPS data (see Table 1). Summer rains are most common in July and August, while winter rains have a peak in November. The mean annual rainfall for the period is 57 mm (red line).

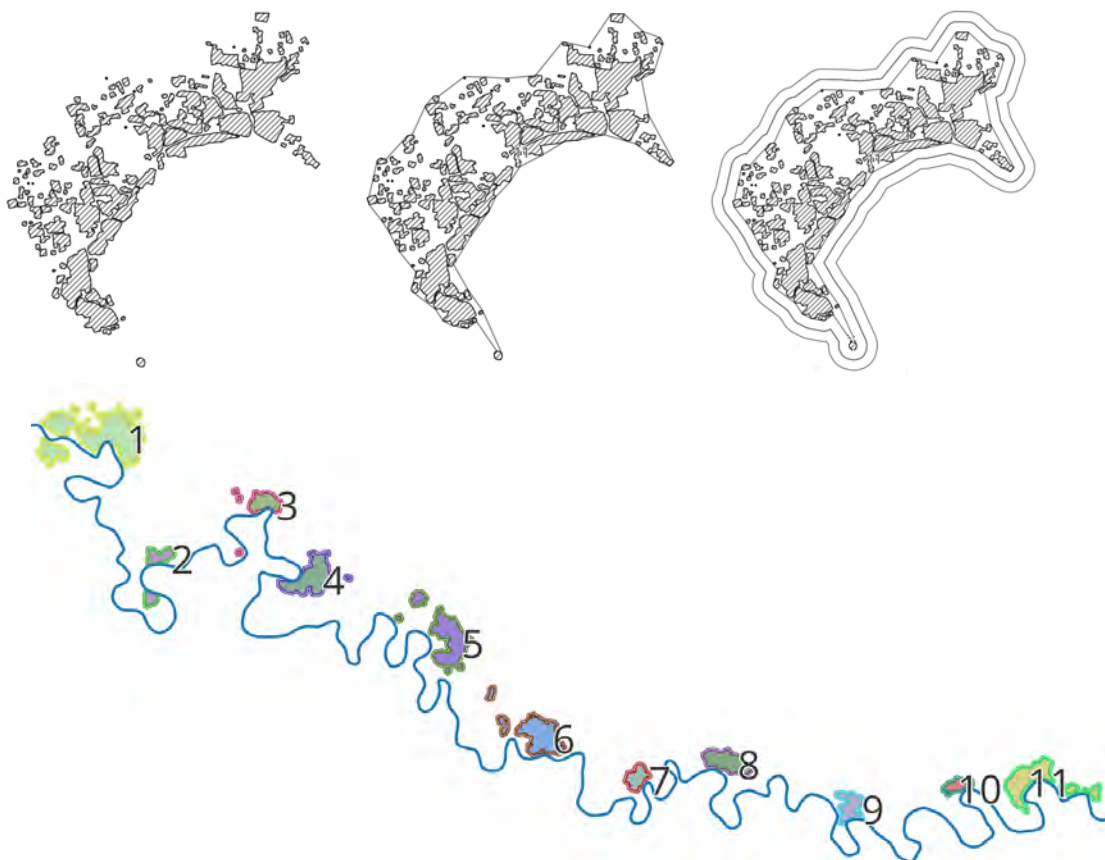
Figure 6: Upper panel: A concave hull was calculated from multiple residential polygons in Rahad River (left) to outline the total village area (middle) and a 100 m buffer was added (right). The latter two types of polygons are the basis for village flood statistics. Lower panel: Village polygons were clustered into 11 regions with IDs from 1 to 11. The buffer zones are visible around each polygon in a contrasting color.

Infrastructure datasets were downloaded from OSM and complemented with our own digitizing to create a more up to date dataset of residential areas. Some residential areas were digitized at a large scale and in order to make village scale polygons they were simplified (1m tolerance), followed by calculation of concave hulls (6 points) that outlined the combined area. In addition to the basic village outline, another outline was made where a 100m buffer was added. These resulting village polygons (with and without buffer) were clustered together into 11 regions that were the basis for summary statistics (Figure 6).

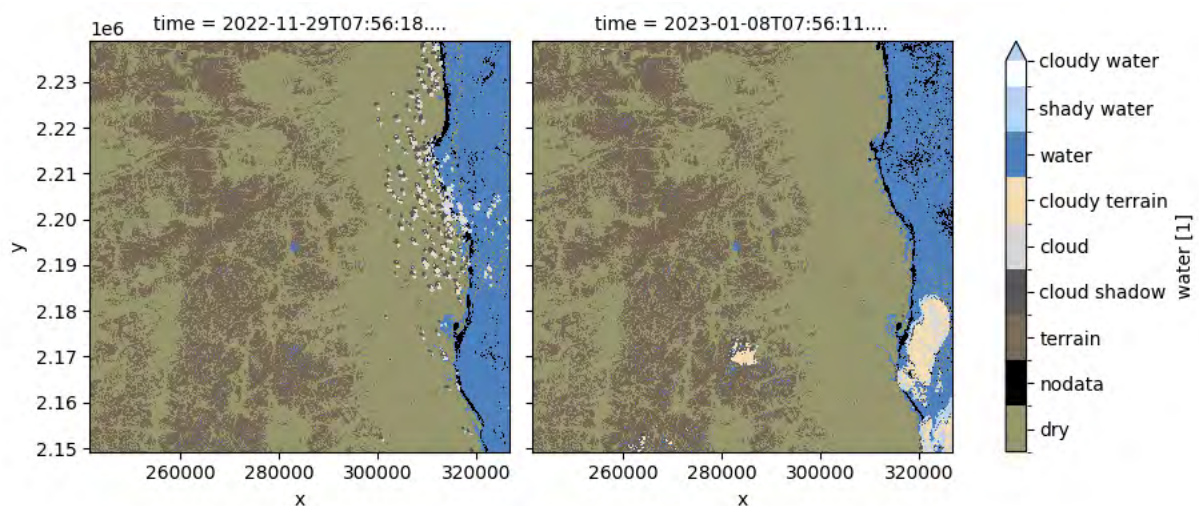
Figure 7: Overview of the selected WofL data for Arbaat study area. These were selected because of low cloud cover in the areas of interest.

To map out the varying dam size and flooded areas in the dam surroundings we used WofS Annual summaries from 2000 onwards. Flooded areas downstream of the dam were also mapped out. This part of the Arbaat catchment, referred to as the *lower catchment*, was extracted from the total catchment area using the SRTM stream network to identify the drainage divide downstream of the dam. Flooded areas were overlaid with the cropland mask (DEA) as explained above. The available WofL scenes from the autumn 2022 flood event were also selected to look in more detail at the development and effects of that event. However, only two clear scenes were available for the period of interest (November 2022 - January 2023; Figure 7).

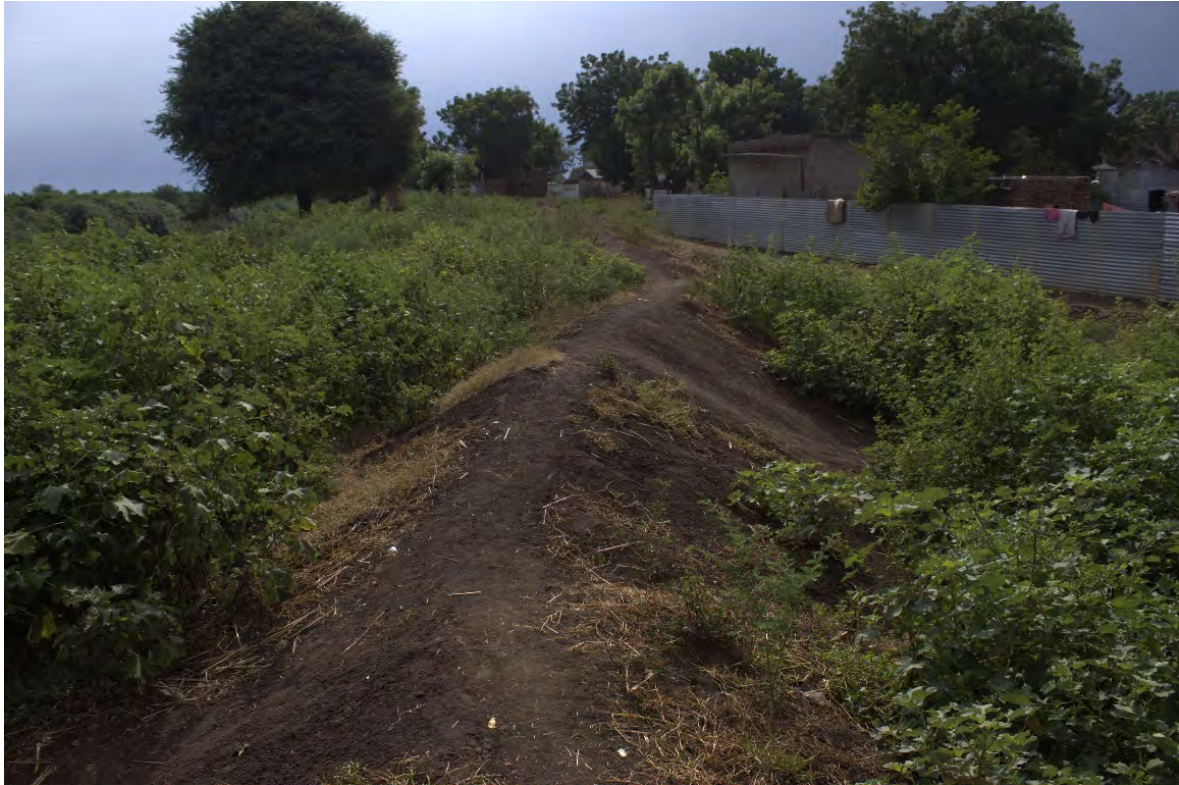
Figure 8: Earth terrace in Afrush Tobak village built in 2022 to protect the village from the flood.

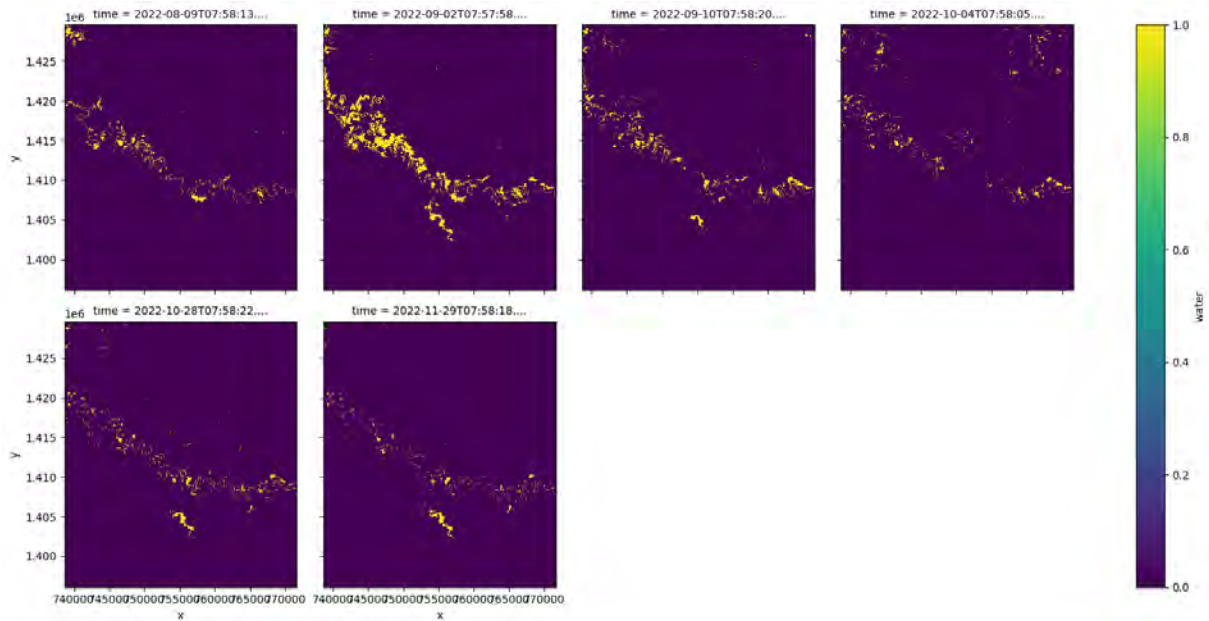
Figure 9: WOfL timesteps with nearly cloud free conditions for Rahad River. Yellow indicates water covered pixels and purple dry pixels.

According to the cloud-free WOfL data the flood started early in August 2022 (Figure 9). It is not possible to identify which date the flood peaked from the data, however, the flooded area is at its most extensive in the WOfL data from 2nd September 2022. By 10th September, there is already a significant retreat of water in the lower parts of the study area. In the upper part of the study area, however, there are still larger water patches visible in late October and water seems to withdraw slower here than in many other areas. There are also scattered areas in the whole study area where water still remains in late November.

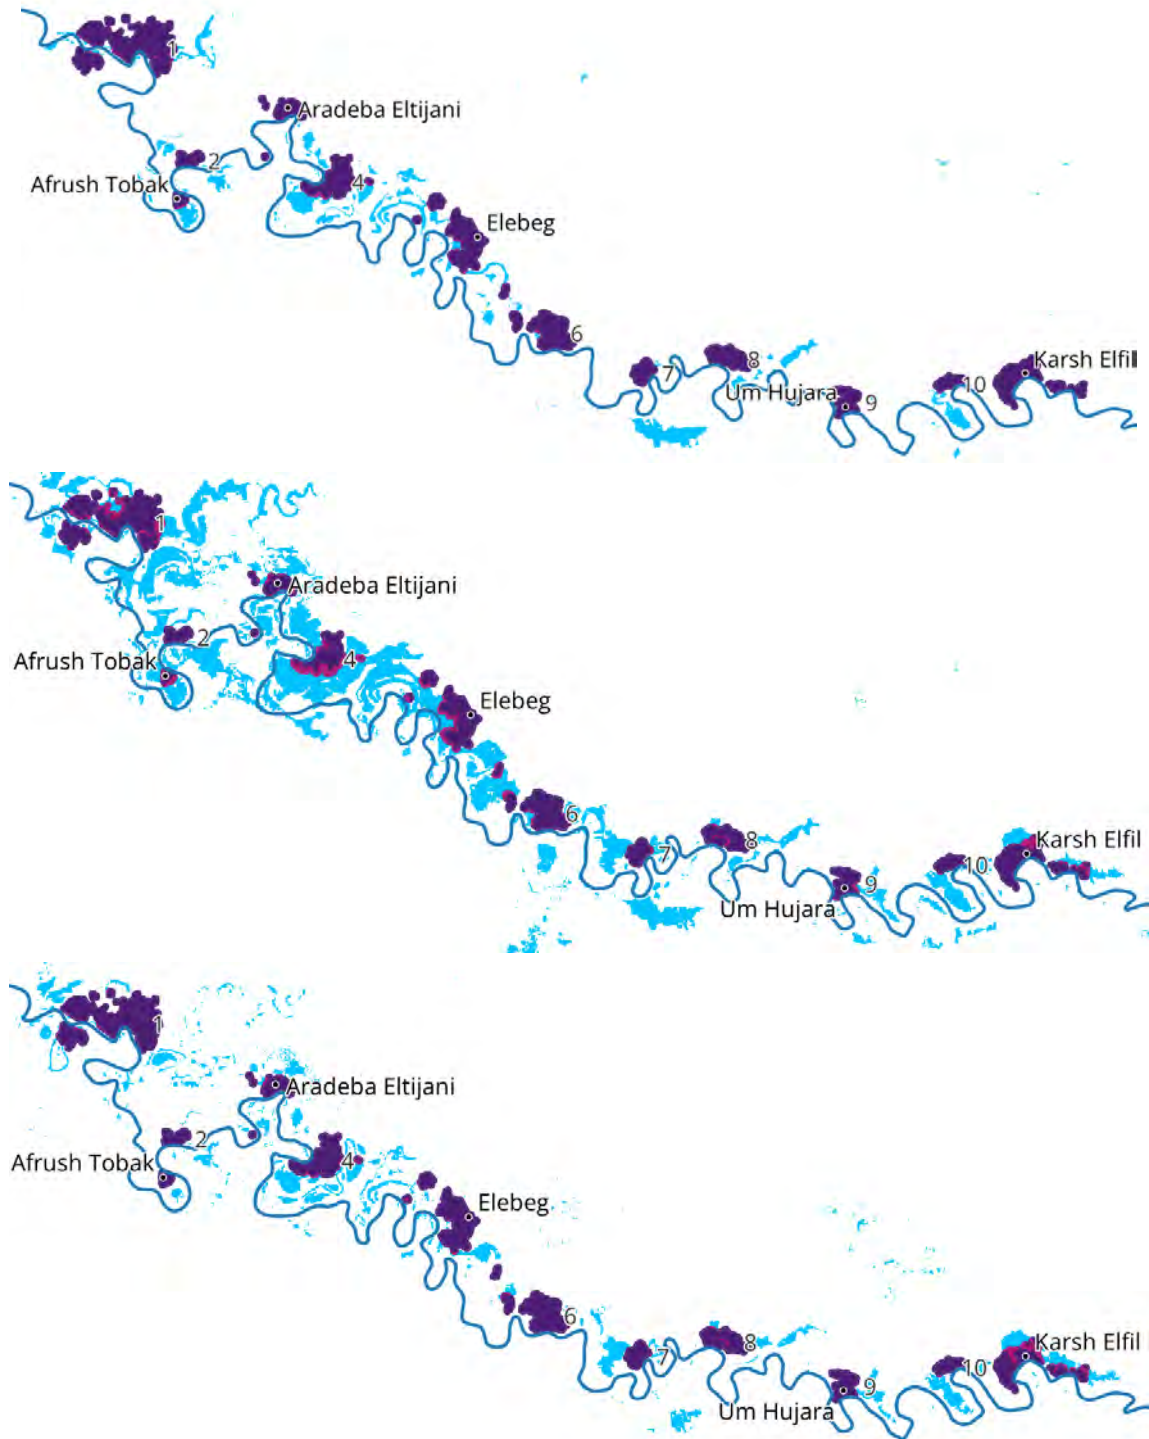
Figure 10: Results from WOfL from 9.8 (upper), 2.9 (middle) and 10.9 (lower). Cyan color are pixels defined as flooded (cf. Table 2), dark purple are residential areas/villages (with 100m buffer) and magenta colors are flooded areas within villages

Looking in more detail at the WOfL data, we can see that the effects of flooding on residential areas were primarily in the buffer zone at the earliest dates (Figure 10). By 2nd September, large water bodies formed on the floodplain as separate or interconnected pools, the majority of which are large in size and in the area south of ID3 and north of ID6 there is one large water body connected to the main river at several places. Close to ID8 and Karsh Elfil (ID11) there are separate water bodies north of the main river. Although several villages are affected at this early stage, it is remarkable that they are placed in areas relatively less affected by the flood. On 10th September, the flooded areas were significantly smaller in general and were also concentrated in the village areas, except in Karsh Elfil where water covered larger areas because a more central (western) part also was flooded. One of the pools close to the village also expanded.

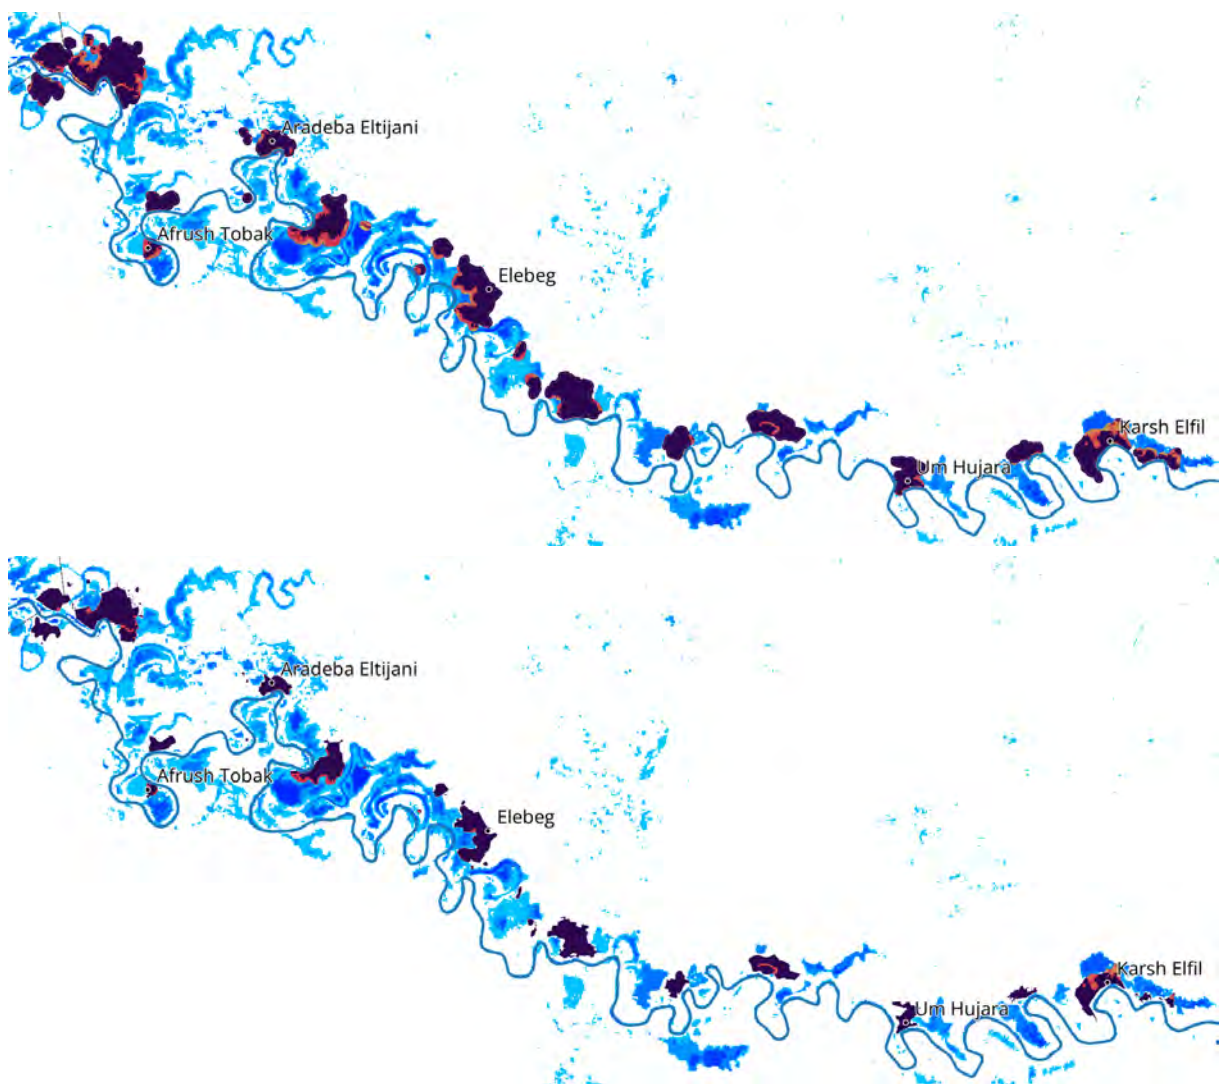
Figure 12: Results from Sentinel 1 and WOfS data combined, for villages (dark purple) with 100m buffer zone (upper) and without buffer zone (lower). Cyan to blue colors are water covered pixels (darker blue with increasing number of times a pixel has been mapped as flooded), magenta to orange colors are flooded areas within villages (more orange with increasing number of times a pixel has been mapped as flooded).

Combining all the datasets (individual, WOfL, and S1) gives an impression of the total flood effect for the whole period it lasted. The above findings are corroborated and in summary we can see that large areas have been affected and that the majority of villages are mainly affected in their peripheries (Figure 12).

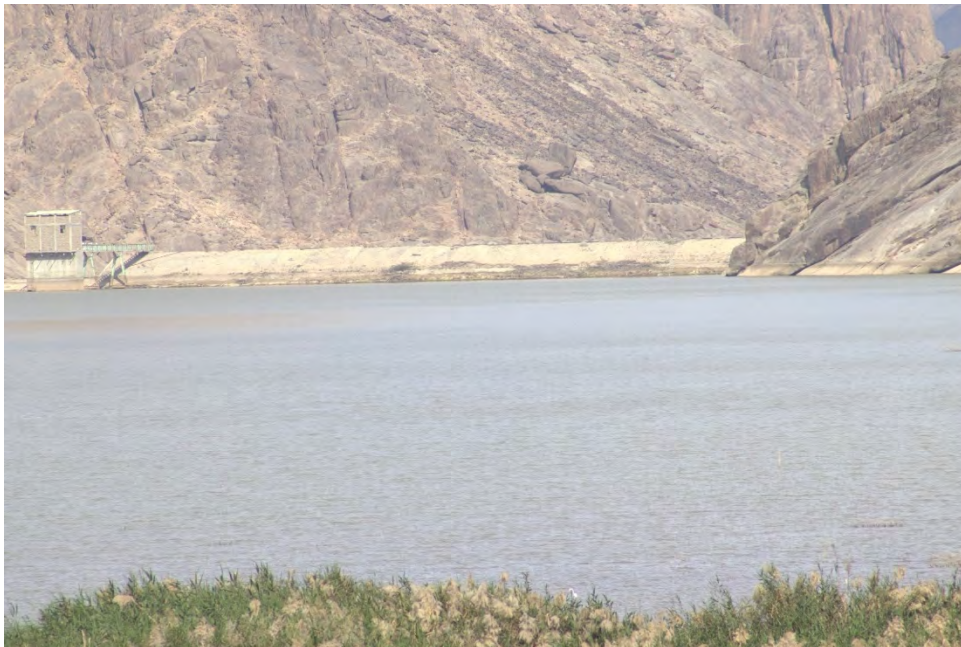
Figure 14: The lake of Arbaat dam in January 2024.

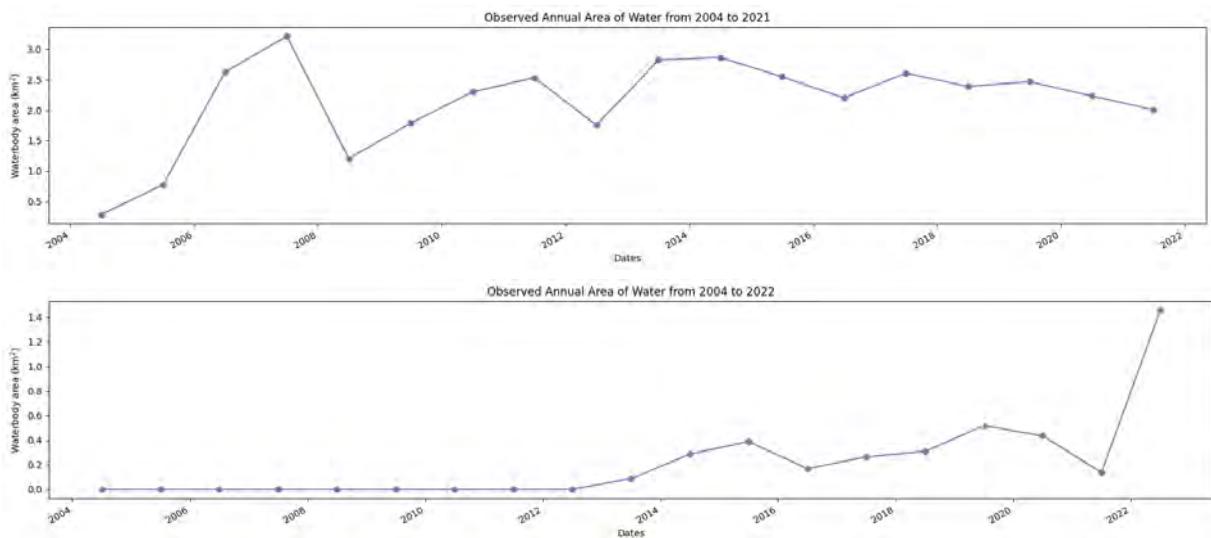
Figure 16: Annual area of water in Arbaat Dam and surroundings. Upper panel: All pixels with a frequency above 0.2 were summed up to calculate the water covered area. Note that the area of interest is the same as in the figure above and that the smaller basin downstream of the dam is included in the estimated area. Lower panel: All pixels with a frequency between 0.01 and 0.05, i.e. flooded areas, were summed up to calculate the water covered area. Note that the area of interest is the same as in Figure 15.

The flooded area (1-5% water frequency in WOfS annual summaries) in around the dam has also varied from year to year (Figure 16 Lower panel). The data, with its limitations, suggest that there has been nearly no flooding until 2013. Thereafter, between c. 0.2 and 0.4 km² have been flooded annually. In 2022 around 1.4 km² was recorded as flooded, which is exceptional compared to previous records. Looking in more detail at this data shows that larger water bodies have formed in various locations in the landscape (Figure 17). Whether these are results of the November 2022 event is uncertain as the WOfL from 29th November does not show these smaller water bodies (Figure A3). CHIRPS data suggest that the main rainfall in the month was between 10th and 12th November (Figure A3).

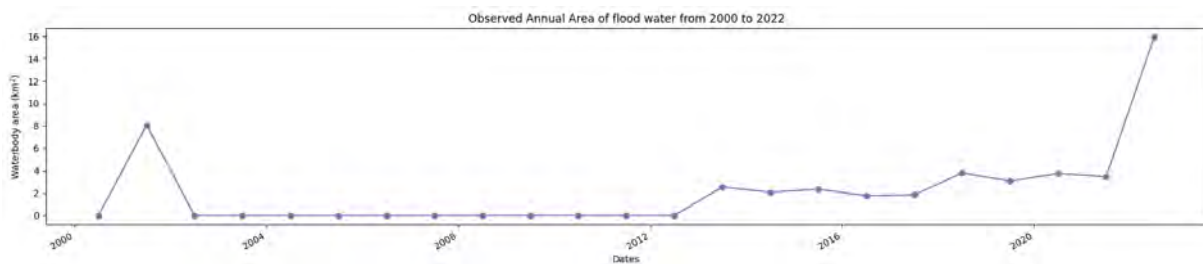
Figure 18: Annual area of flood water in lower Arbaat catchment between 2000 and 2022. All pixels with a frequency between 0.01 and 0.05 were summed up to calculate the water covered area.

The flooded areas in lower Arbaat catchment show the same temporal development as described above. The total covered areas of flood water according to the WOfS annual summaries for the lower catchment is in the range of 2-4km² for most of the years since 2013, except for the exceptional levels in 2022 (Figure 18).

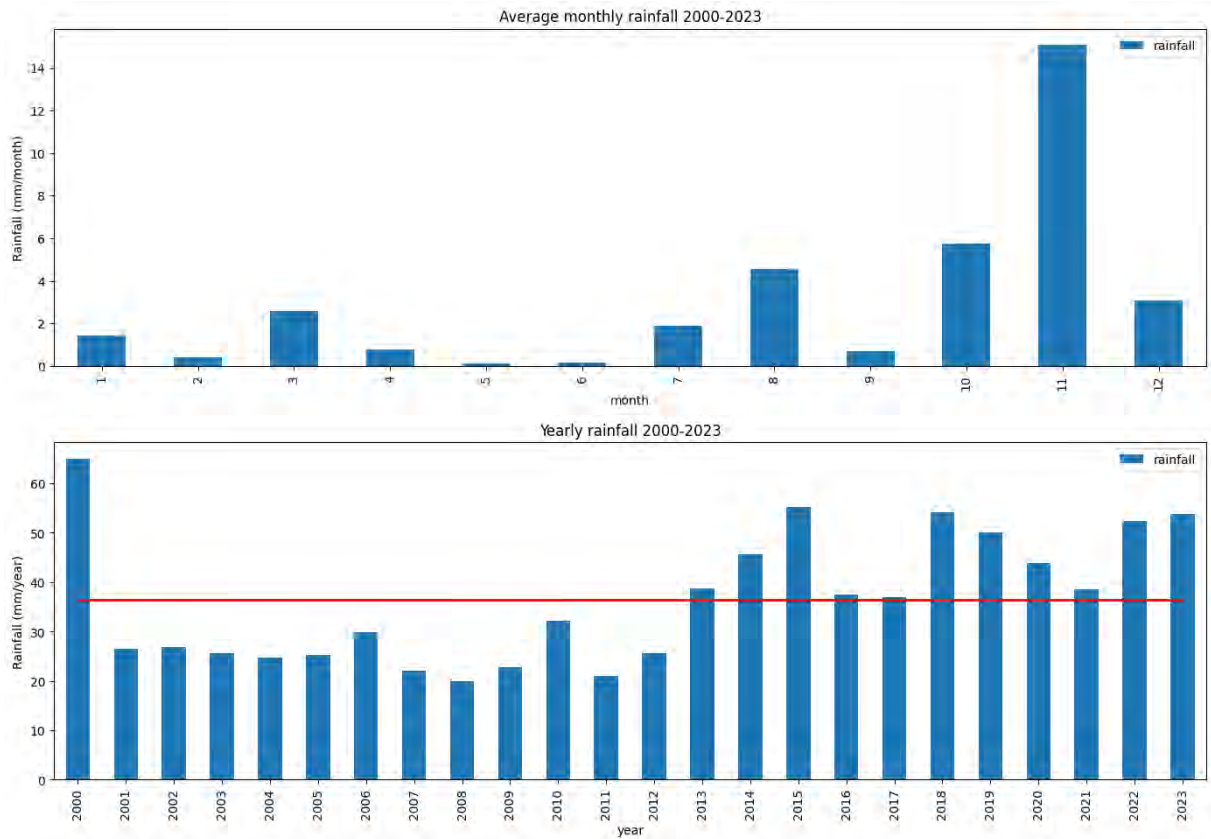
Figure A4: Annual (red line indicates average) and monthly rainfall in lower catchment, below Arbaat Dam from 2000 to 2023, according to CHIRPS data
